Pole Top Deterioration Study For The Electrical Utility Industry

**This research study was conducted to determine the causes
behind wood pole top deterioration**

Robert P. Butler

January 2018

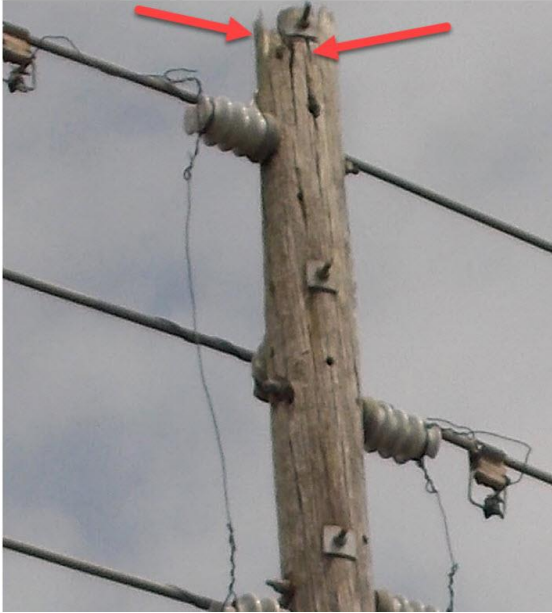
70s Penta, hollow shell gives way with conductor load.

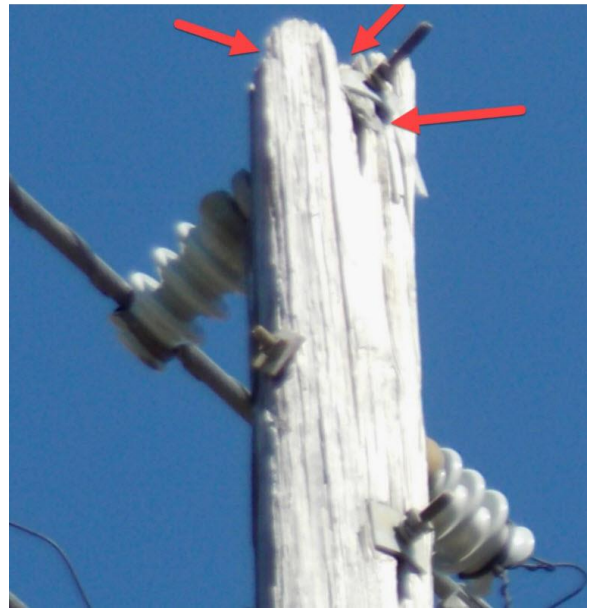
70s Penta, hollow out until shell gets too thin, then gives way

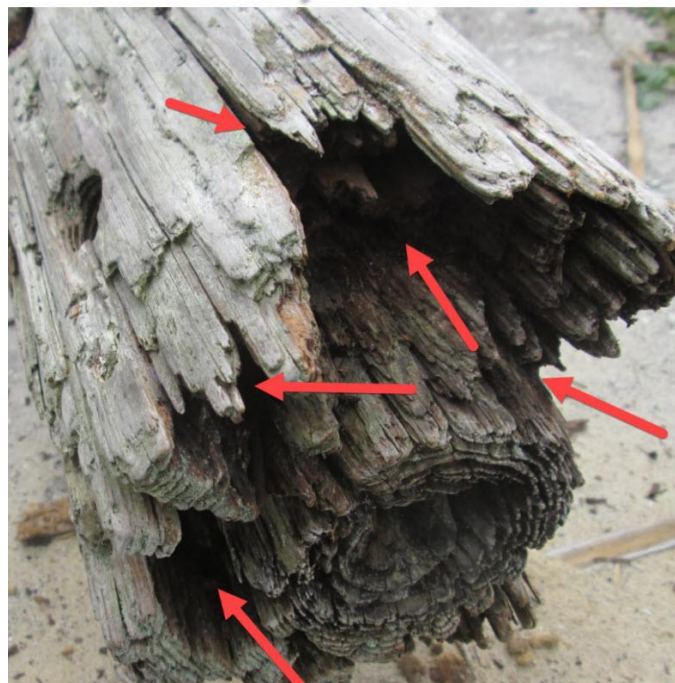
43 Yr old Penta, major damage extremely deteriorated

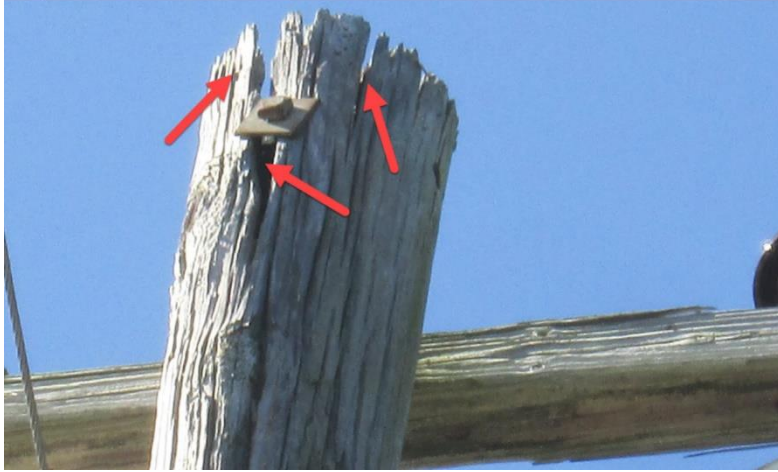
Late 70's pole in the field, Penta, major damage to crossarm pole

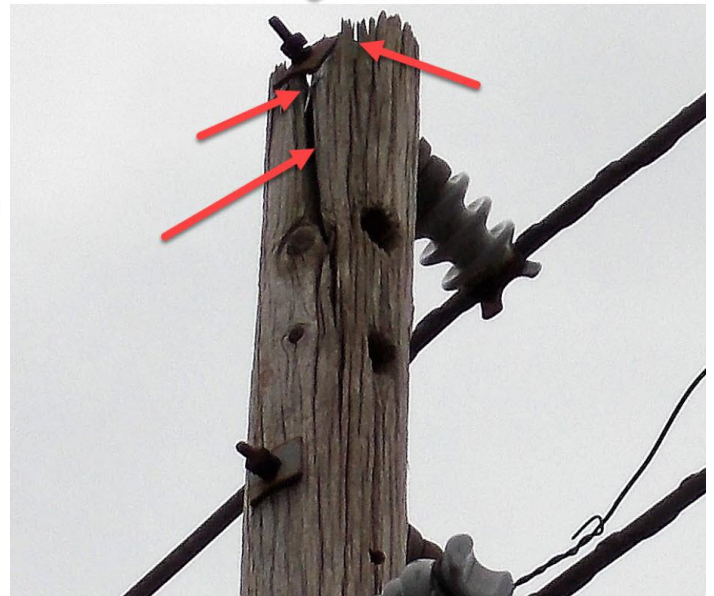
Late 70s Penta, not much left holding this feeder.

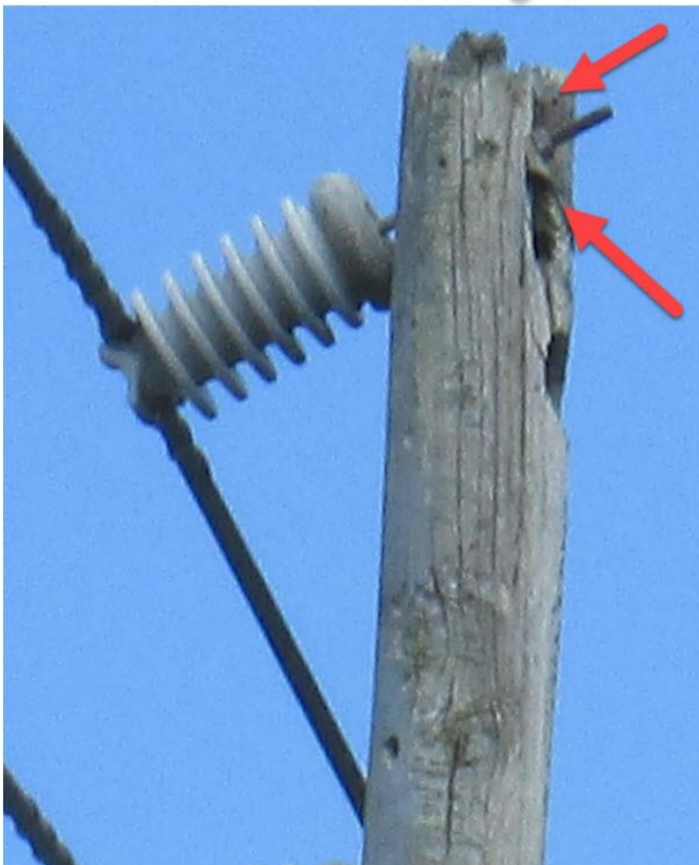
Late 70s Penta, soft top needs stronger top reinforcement to hold conductor weight.

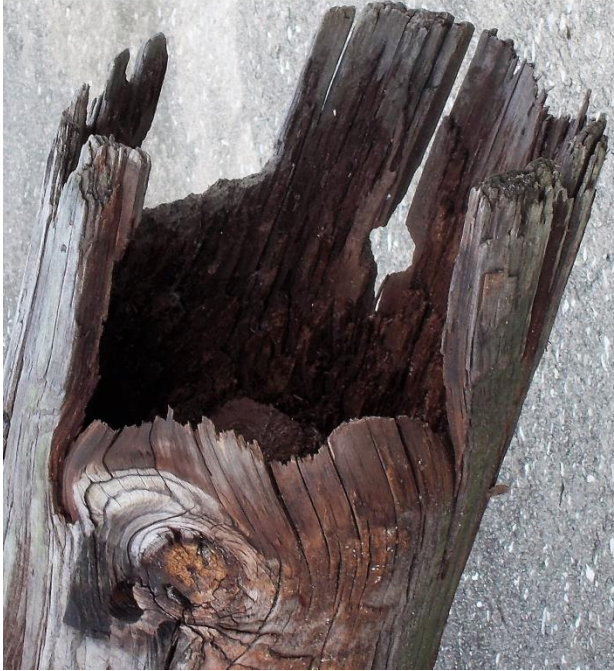
Old Creosote removed from the field, hollow top finally gave way.

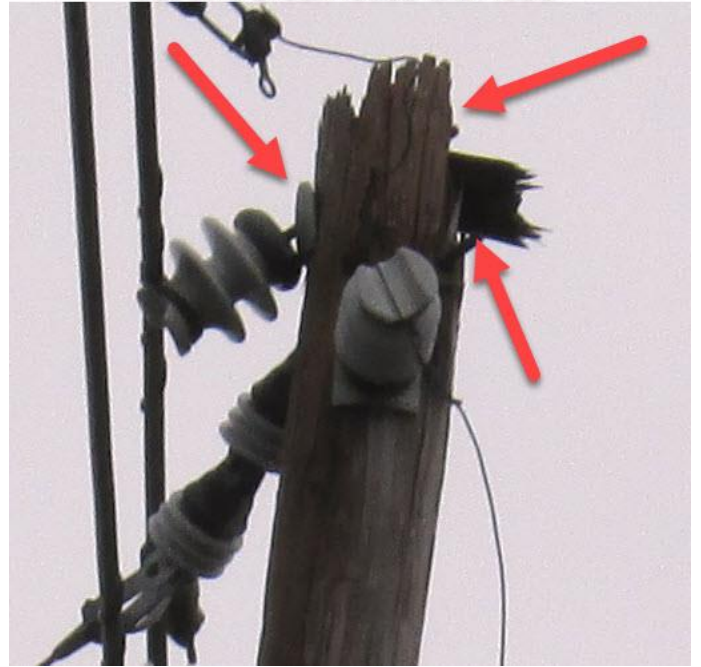
Creosote older than 40 yrs will hollow out and break loose with load

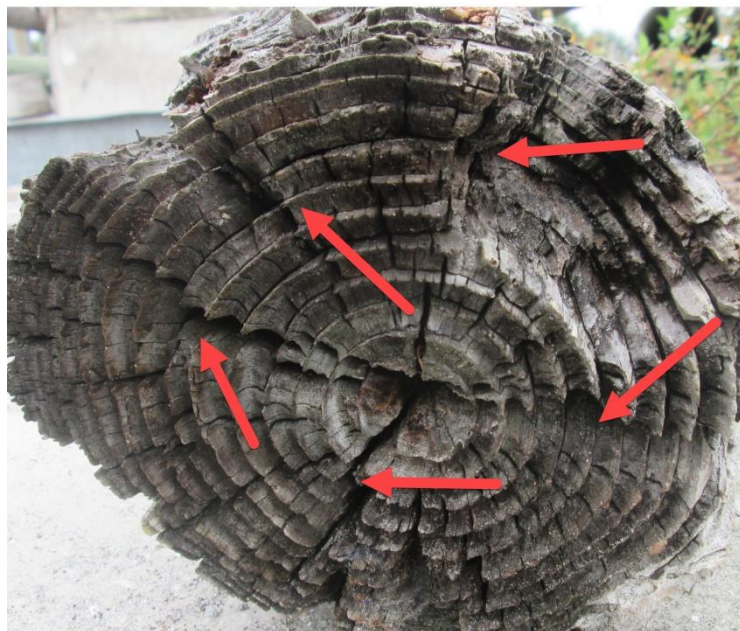
45 Yr Old Creosote, major splitting, top deteriorated down 2"-3"

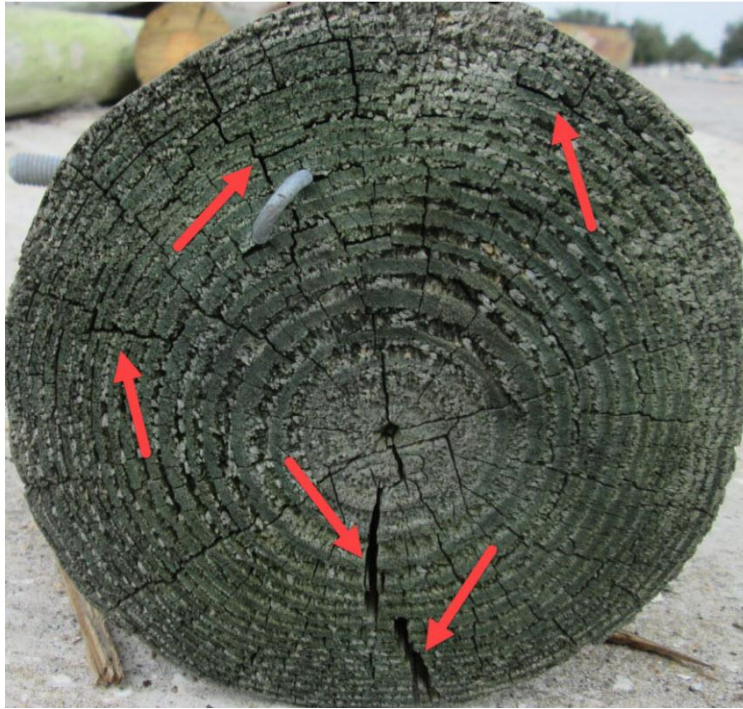
16 Yr Old CCA, minor splitting starting

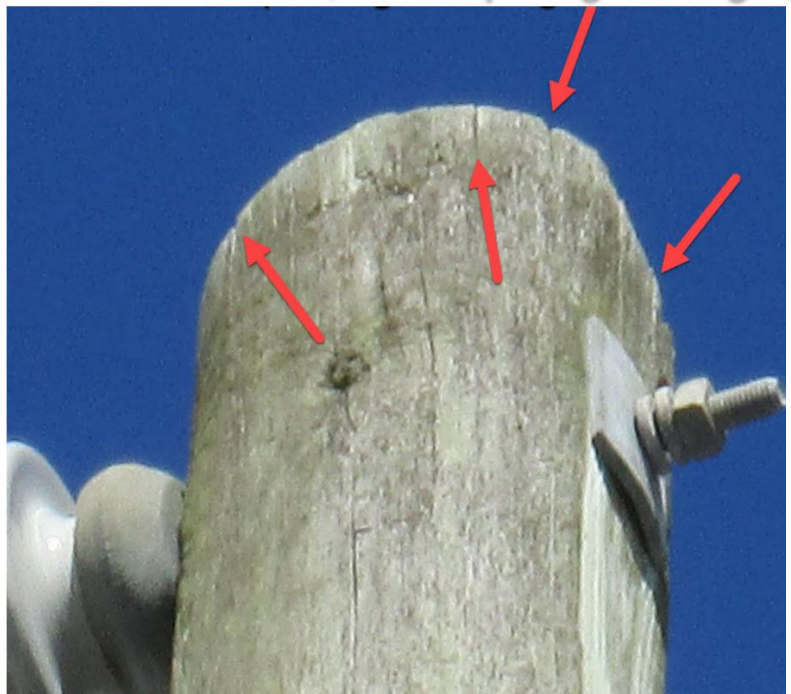
23 Yr Old CCA, minor splitting starting

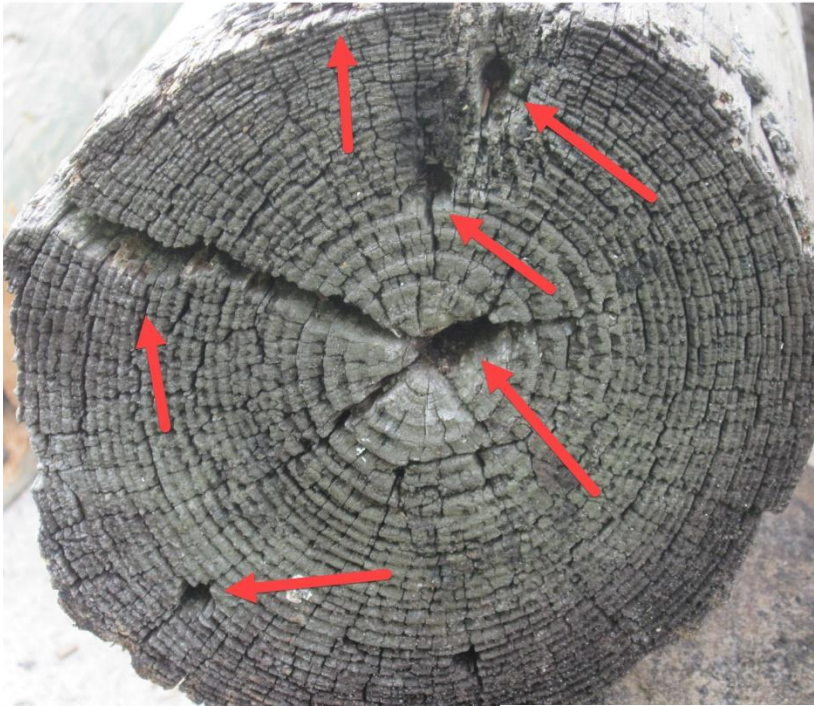
32 Yr Old CCA, large cracks and holes opening up

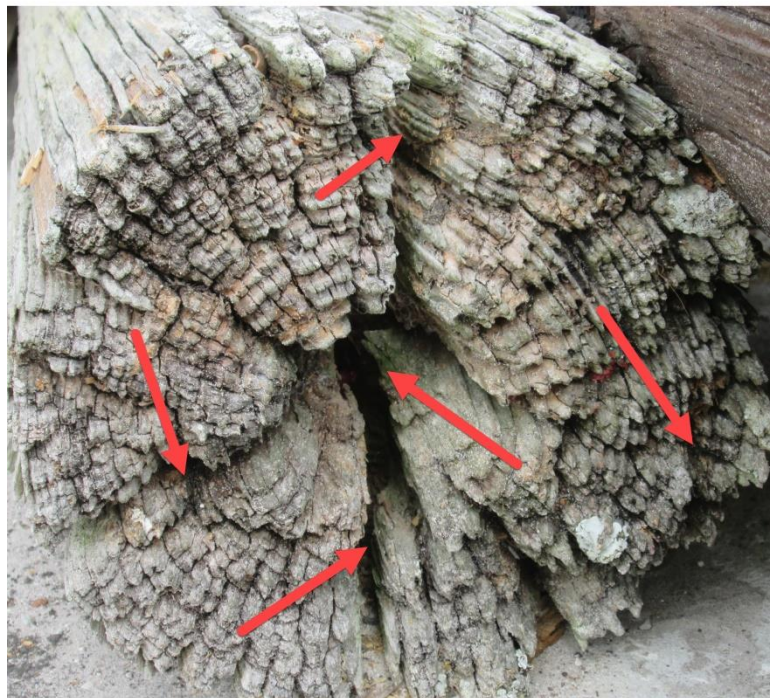
33 Yr Old CCA, several deep wide cracks, top decayed down 3"

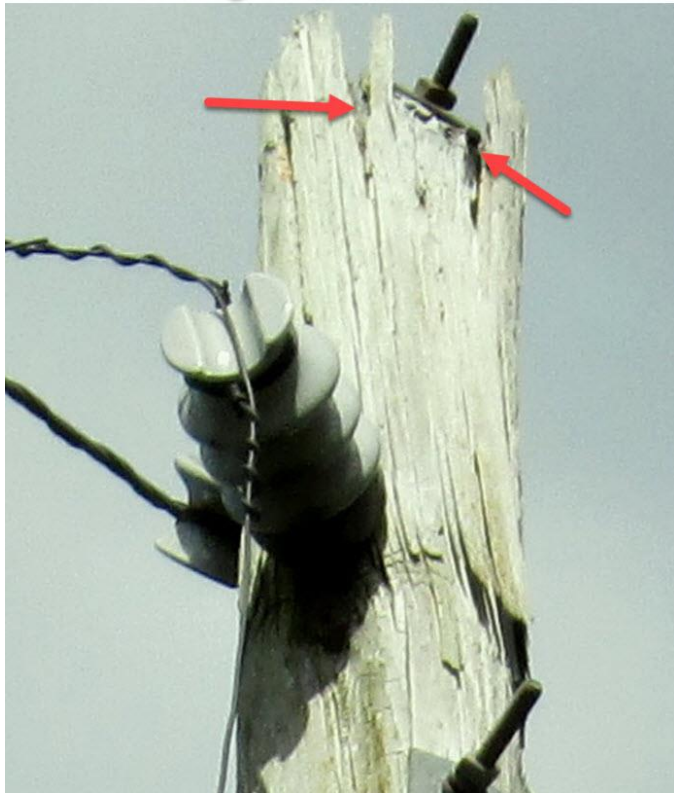
As these CCA poles age and become soft at the top, the primary insulator starts to pull through the pole and is left hanging by the remaining limited structure of the pole.

Early 80s CCA. top can not hold weight of conductor

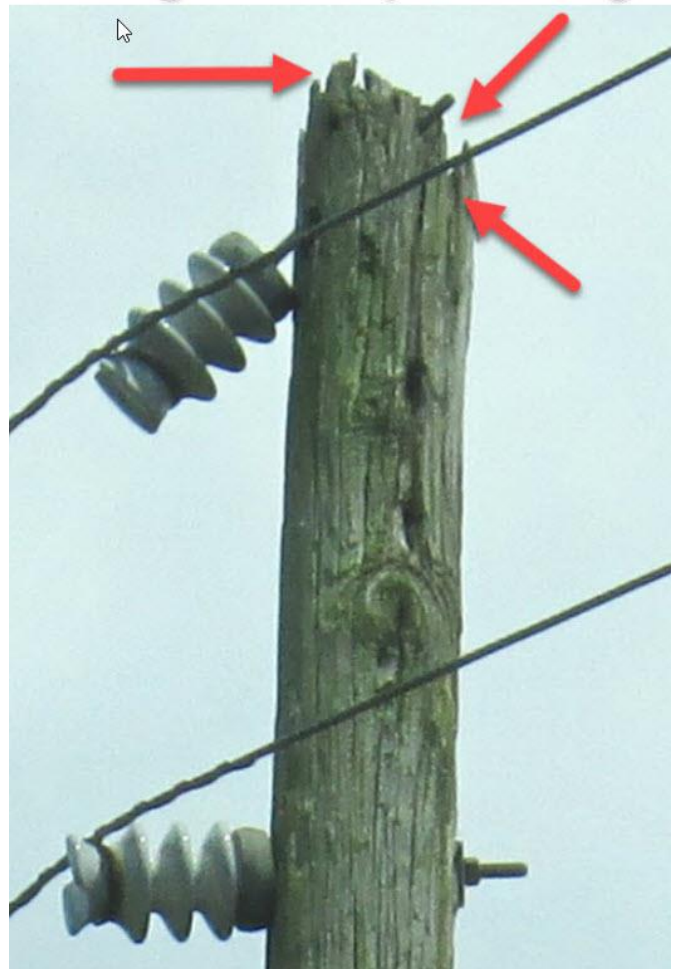
Early 80s CCA, tops get soft causing bolts to pull through

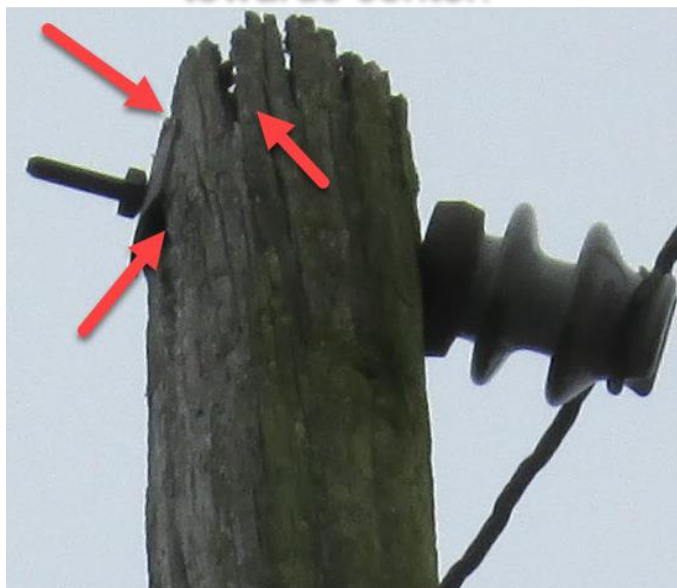
Early 80s CCA, soft top conductor weight pulling bolt towards center.
